**Improve the Quality and Service Life of
Water-based Pavement Marking Paints on
Pavements with High-Iron Aggregates
Final Report**

Prepared by Jacobs Engineering Group Inc. for the
New Hampshire Department of Transportation in cooperation with the
U.S. Department of Transportation, Federal Highway Administration

1. Report No. FHWA-NH-RD-15680J	2. Government Accession No.	3. Recipient's Catalog No.	
4. Title and Subtitle Improve the Quality and Service Life of Water-based Pavement Marking Paints on Pavements with High-Iron Aggregates		5. Report Date August 2015

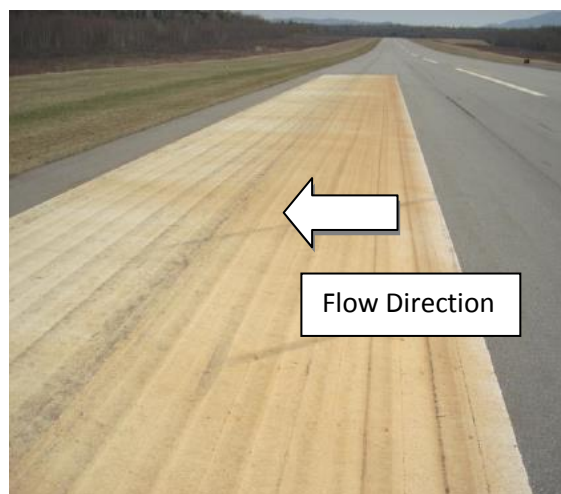
Before describing the work and methodology, an illustration of the paint staining problem is warranted. Staining of paint markings on airport pavement has been noted to occur by two means: over-pavement sheet flow during rain events that carry stains onto the paint markings (Figure 1), and rusting aggregates that create point stains within the pavement markings (Figure 2).

Figure 1 – Sheet flow stains

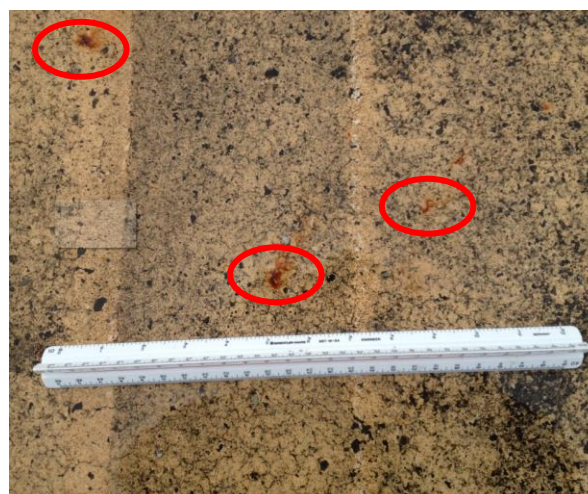
Figure 2–Point stains (red circles)

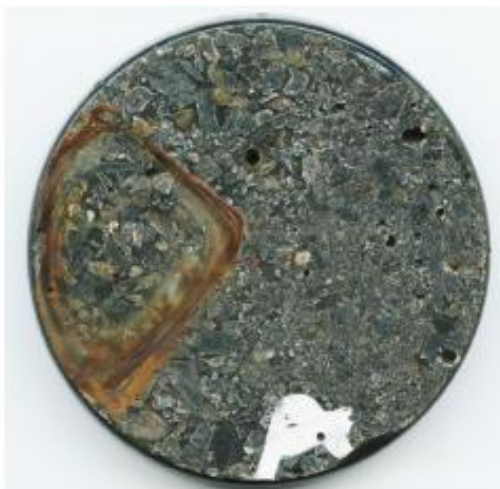
Figure 8- Laboratory Aging Test Rust Stain

The test resulted in rust staining. The rust originated in the aggregate then became mobile within the pavement matrix, similar to what happens in the field on the paint markings and the bituminous concrete surface.

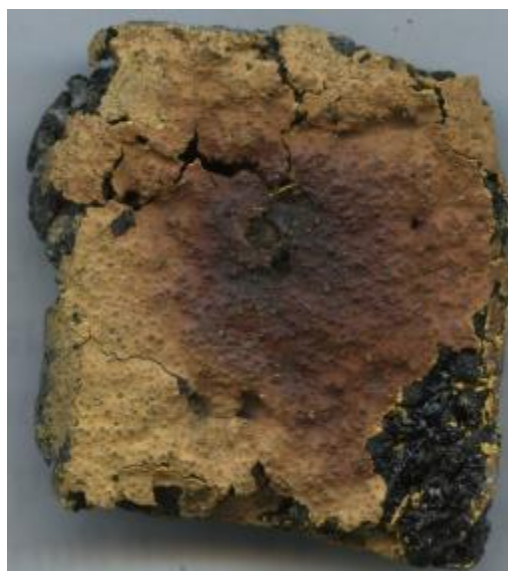
The EDS results show high iron (Fe) content in locations on paint chips that are stained. This confirms the staining is rust. The EDS data includes multiple sample points on individual paint chips. The higher Fe percentages were found on the darker stains and lower Fe percentages on the lighter stains. Paint chips were collected from 8 different projects. All 5 airports selected for the study were included. All the paint chips had some level of rust staining.

Figure 9 - Sample Rust Stained Paint Chip

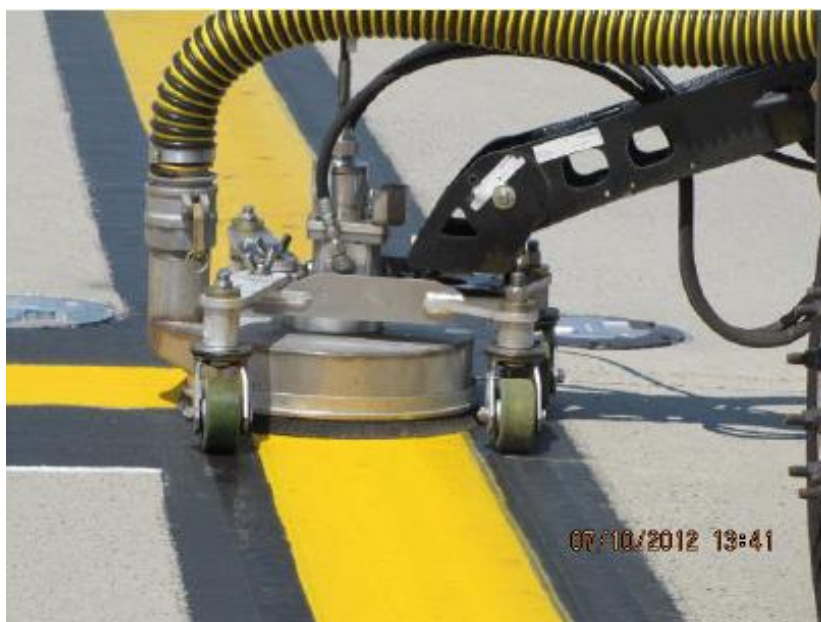
Figure 10 - Paint restoration (Speidel, 2008)

Pressure washing uses a pressurized water spray to remove the surface stained material. The water pressure selected for rust removal is important to preserve the existing paint and glass beads that are on the surface of the paint. Glass beads are used to reflect paint color to the pilots under low light conditions. The amount of water pressure used to remove rust build-up must be less than the pressure used to remove paint build-up. The higher pressures used to remove paint will

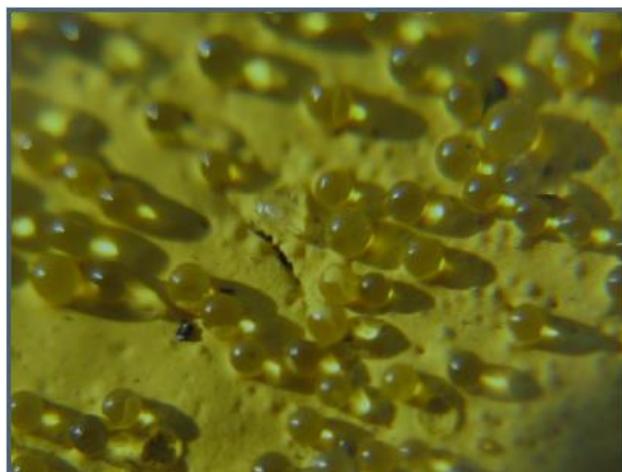
Figure 16 – Poorly placed beads (Speidel, 2014)

Type I, Type III and Type IV Gradation A beads have maximum diameters of 850, 1180 and 1700 microns, respectively.²⁸ The respective conversion to mils is 33, 46 and 66 mils²⁹. Therefore, based upon the 50 to 60% anchor depth, the wet film paint thickness for Type I beads should be 17-20 mils; the wet film thickness of Type III beads should be 23-28 mils; and the wet film thickness for Type IV beads should be 33-40 mils.

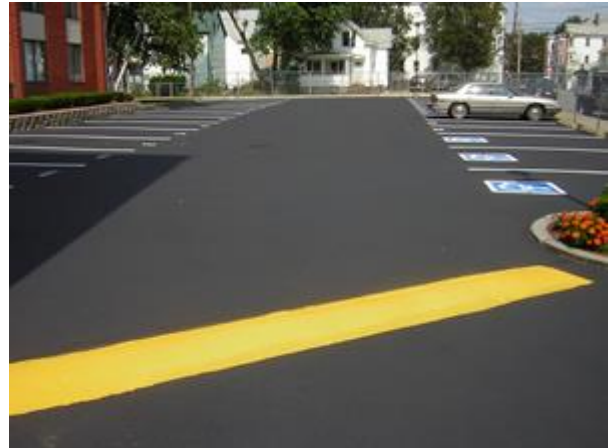
Sealing pavements is a common method to preserve the pavement life. Sealing the pavement would encapsulate and therefore repel the moisture from contacting the aggregates that contain iron. This would eliminate the development of the rust point stains. In the pavement cores taken from the NH airports, those that were sealed exhibited no surface rusting.

Figure 18 - Sealed and painted pavement

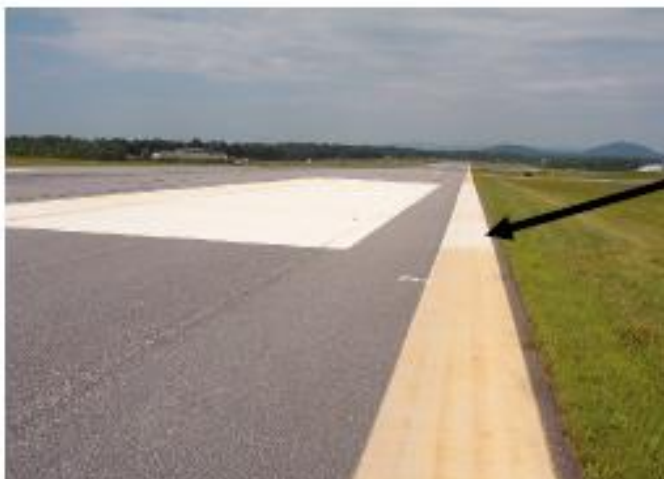
The grooves would concentrate the rainwater flow. This would increase the velocity of the water and, in theory, allow the rust deposits to stay suspended in the water until the water runs off onto the pavement shoulder. On non-grooved pavement, rainwater spreads out and travels slower. Slower water drops the rust particles onto the pavement and paint surface. The grooves could be cut for the larger markings (aiming points, touch down zone, threshold and edge stripes). Figure 20 shows reduced rust stains where the pavement is grooved (black arrow pointing to grooved pavement).

Figure 20 – Grooved Pavement Example (white with black arrow) and not grooved (stained) pavement (Speidel 2008)

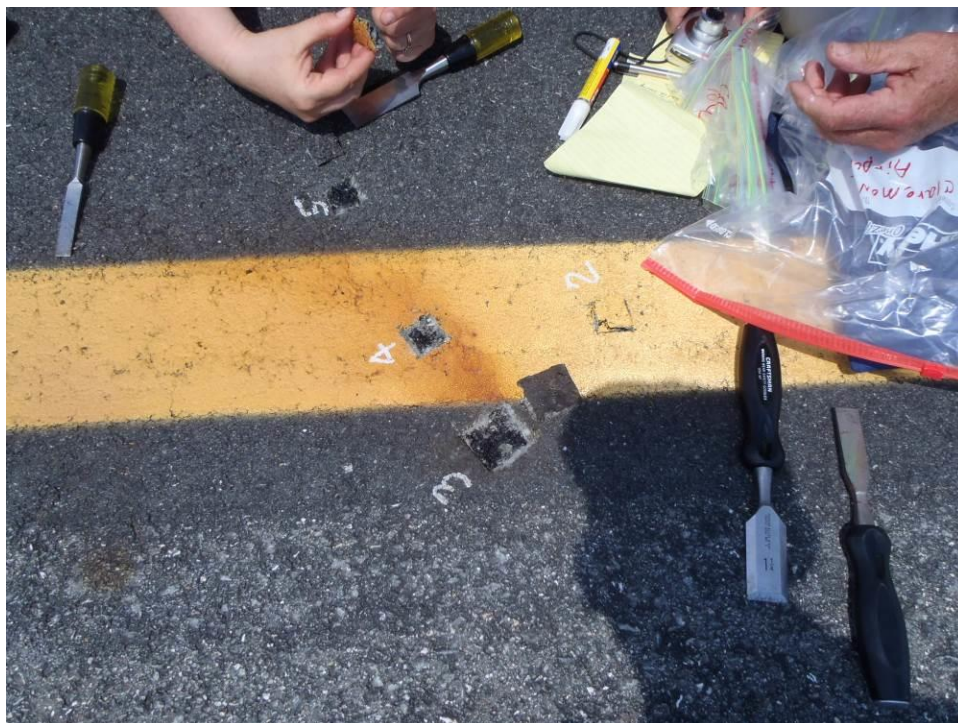
Photo 5 – Paint sample 2 located on no stained paint. Paint sample locations 3, 4 and 5. Sample 3 up gradient, 4 on the paint and 5 down gradient.

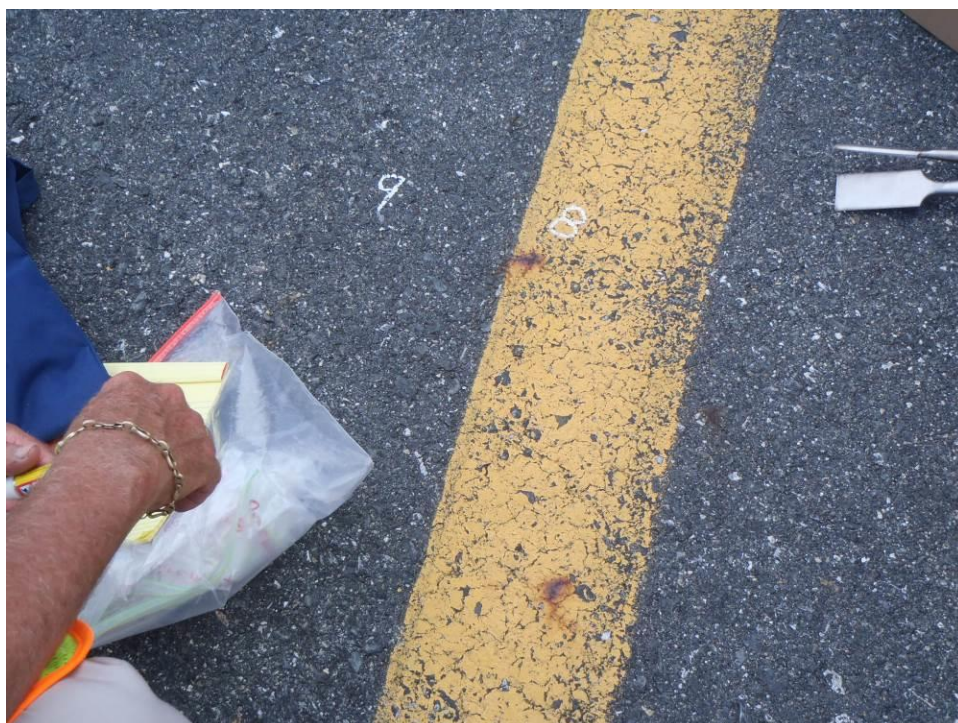
Photo 8 – Paint sample locations 8 and 9. Note sample 8 is on a stain and 9 is not.

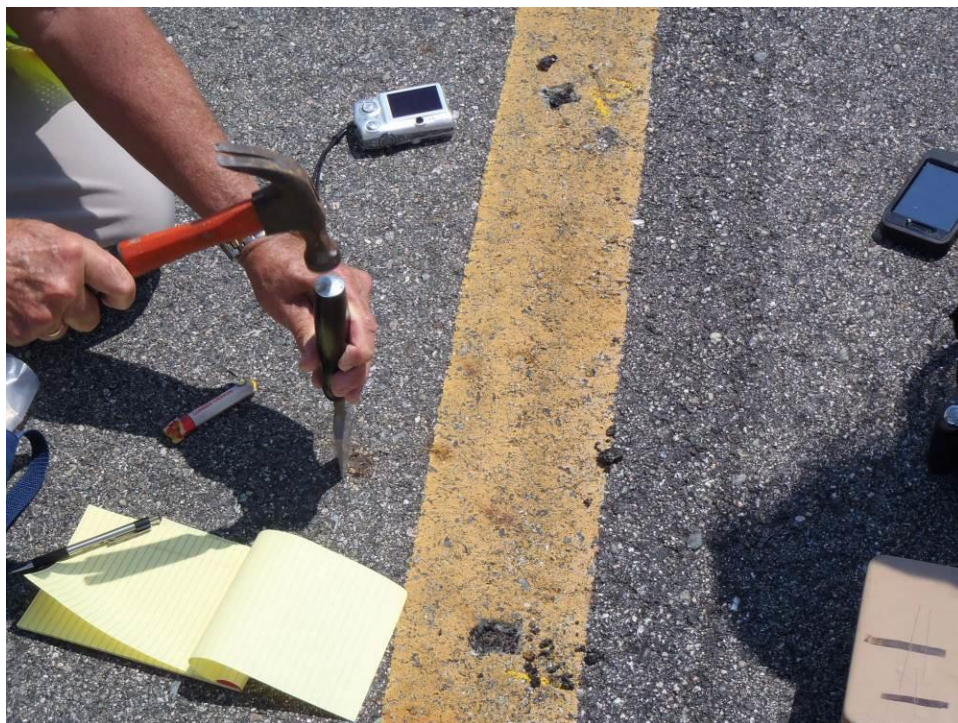
Photo 4 – Sampling of rust stain location 3.

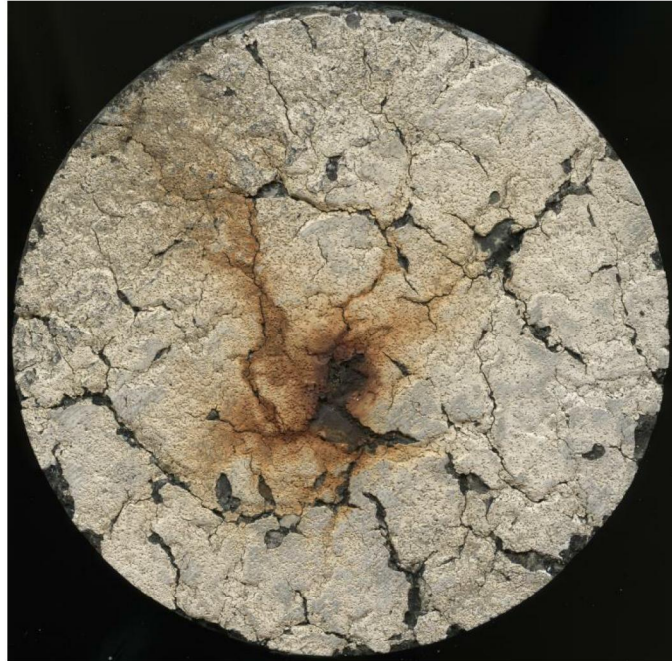
Figure 1 Concord core showing source of major iron staining

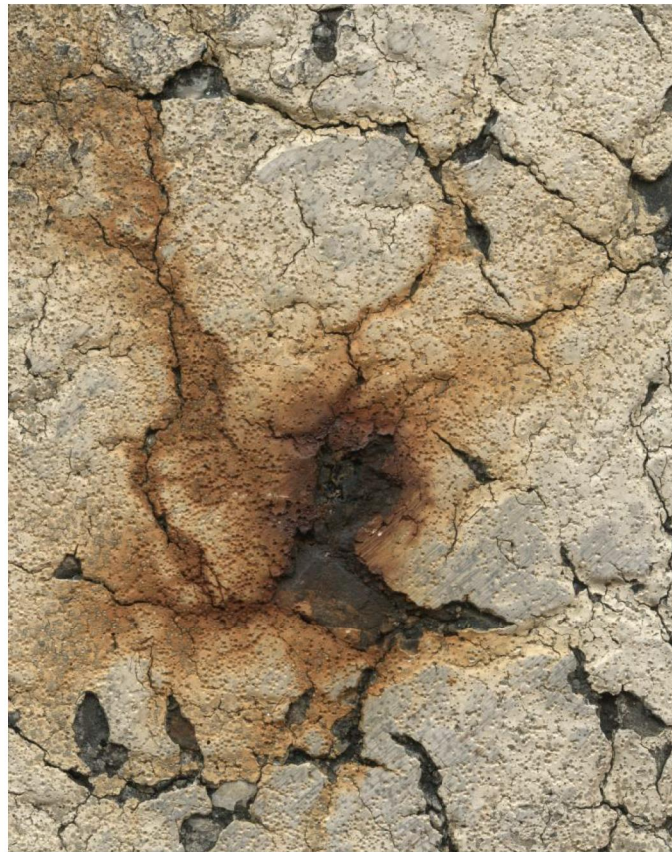
Figure 2 Close up of Figure 1 showing iron staining

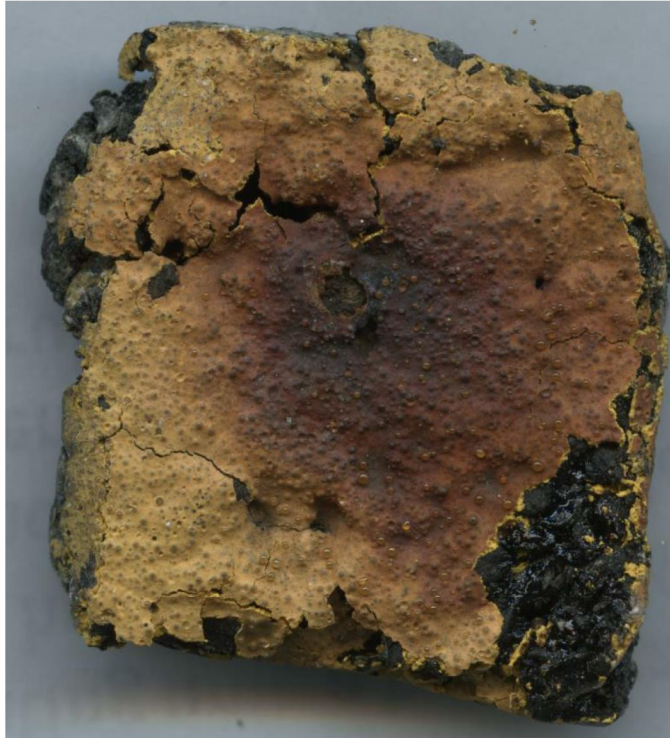
Figure 3 Claremont paint chip showing source of iron stain

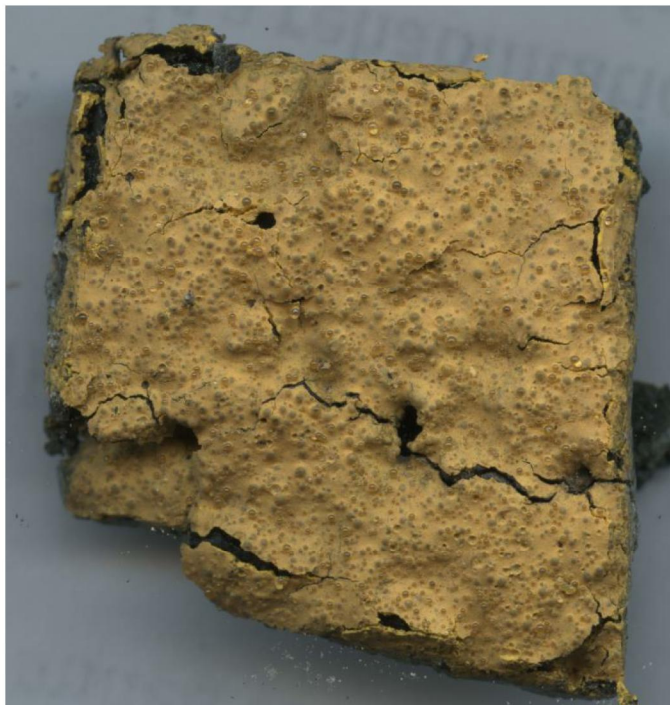
Figure 4 Claremont paint chip showing uniform iron stain coating

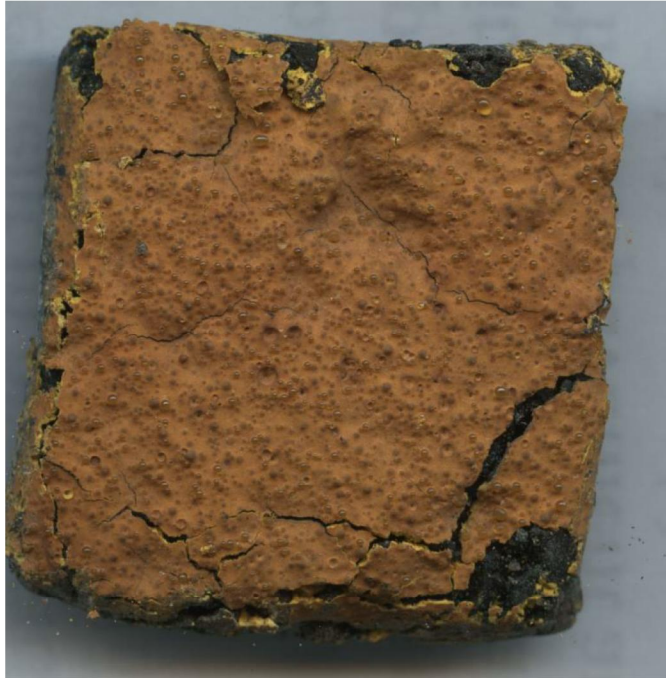
Figure 5 Claremont paint chip showing uniform iron staining (note original paint color at fractures)

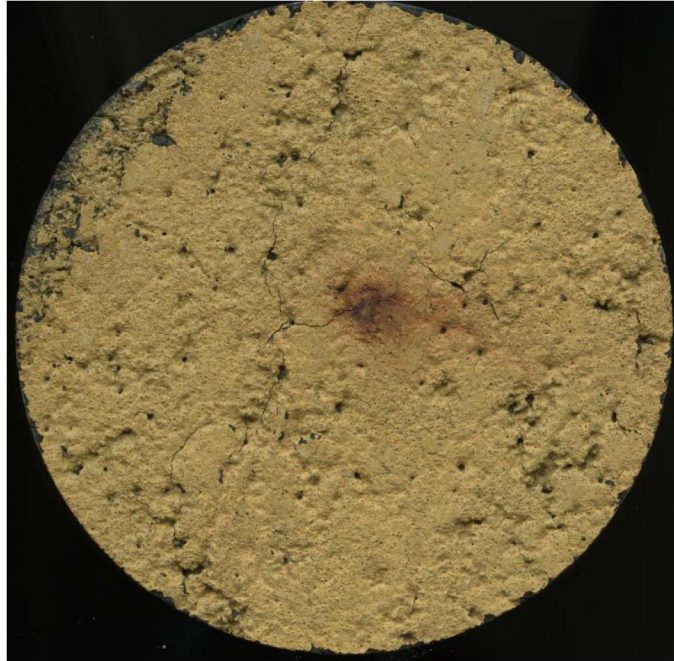
Figure 7 Claremont core showing iron staining

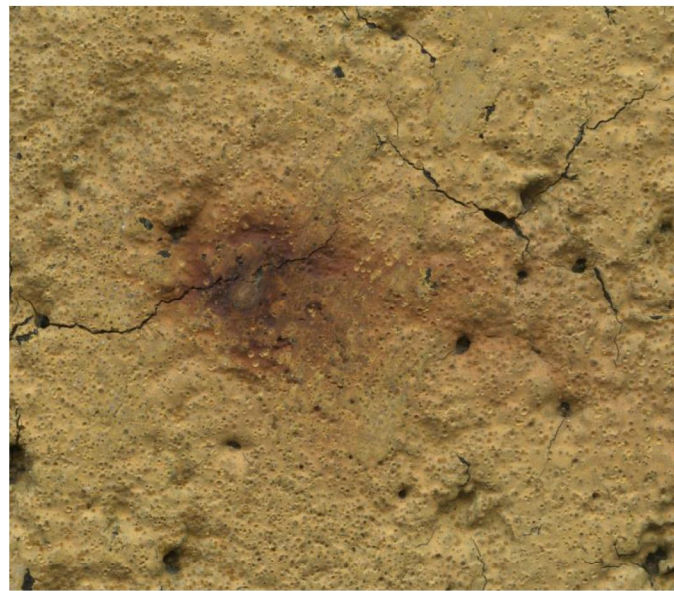
Figure 8 Close up of stain source on Figure 7

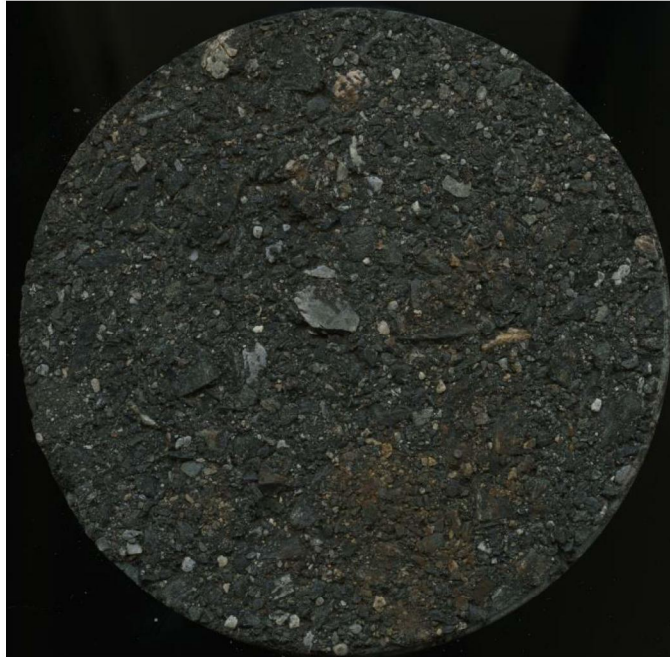
Figure 9 Claremont core without paint showing no obvious iron staining

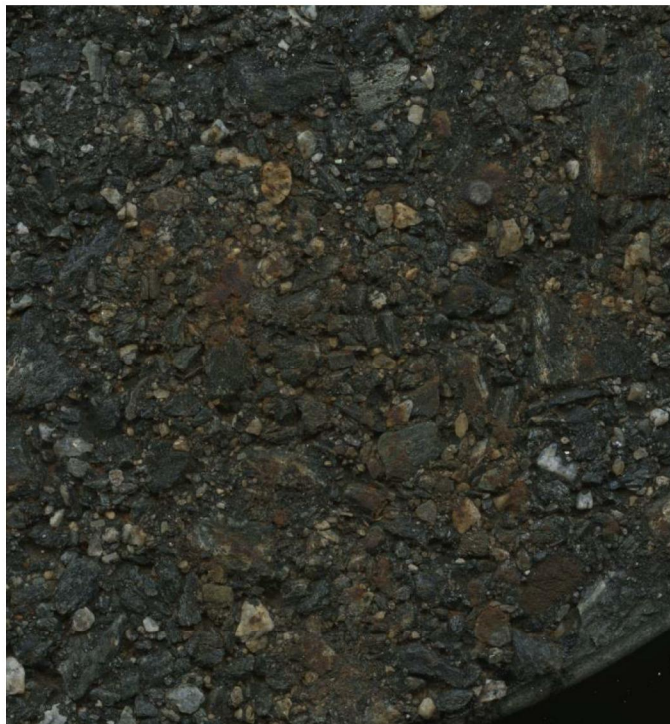
Figure 10 Close up of Figure 9 showing uniform iron staining of the exposed aggregate

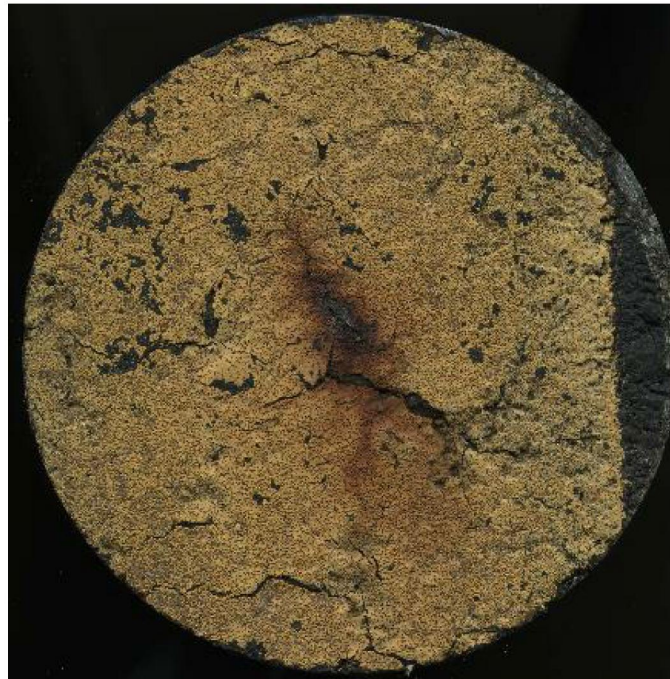
Figure 12 Keene core showing source of iron staining

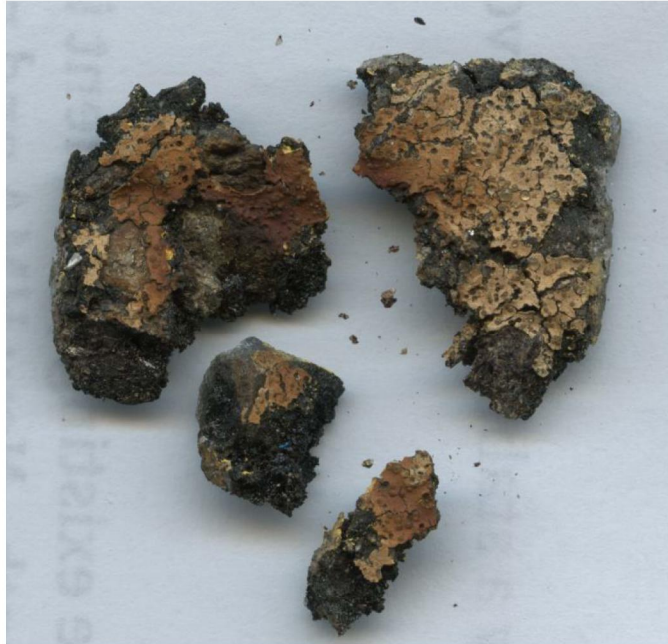
Figure 16 Laconia paint chips showing iron staining

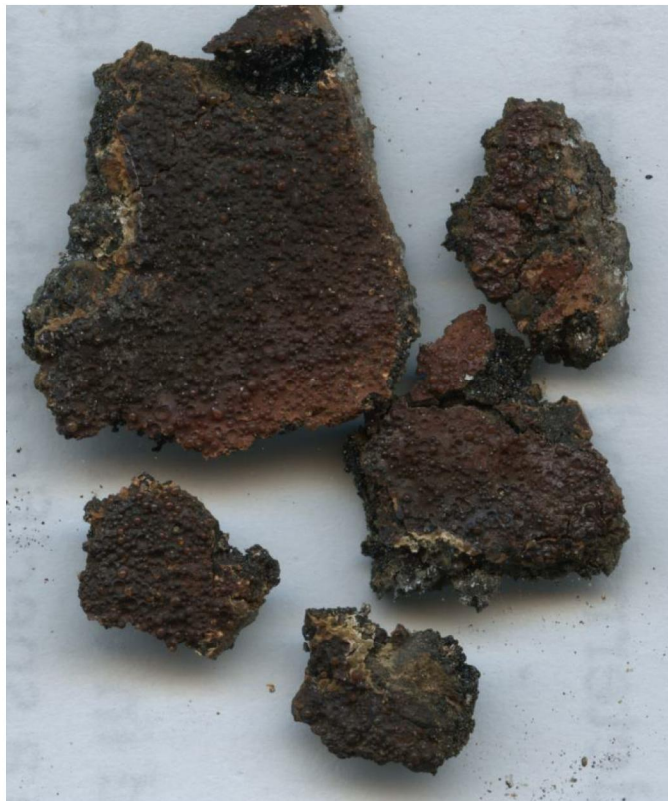
Figure 17 Laconia paint chips showing major iron staining

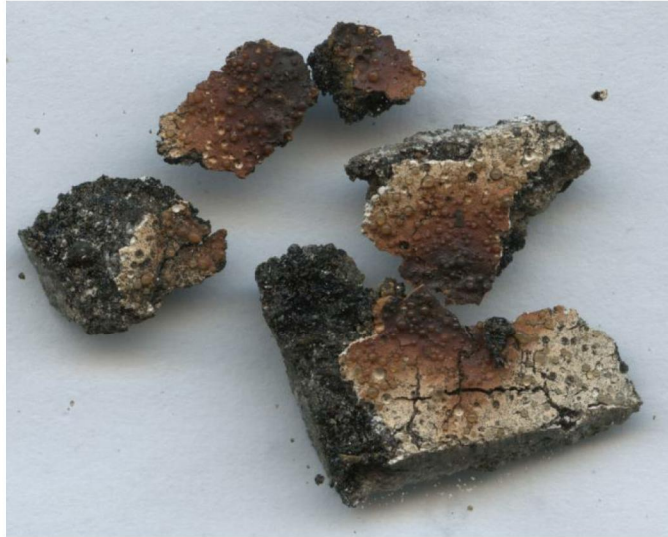
Figure 18 Laconia paint chips showing source of iron staining

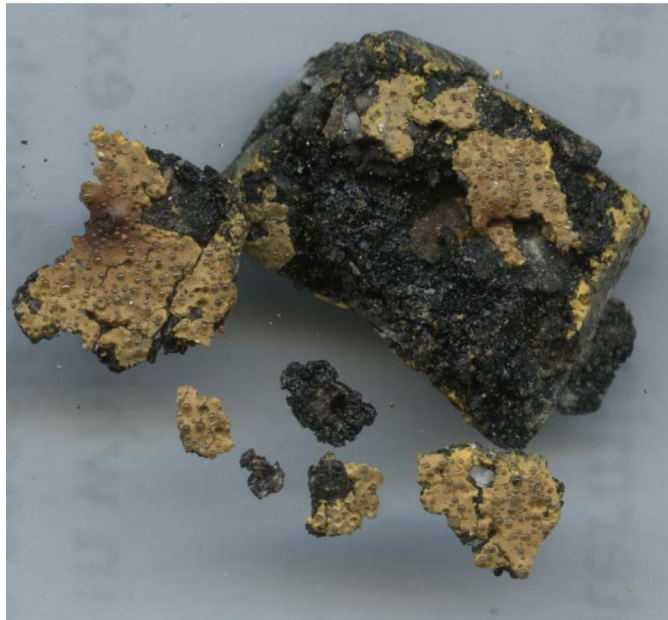
Figure 19 Laconia paint chip showing stained glass beads

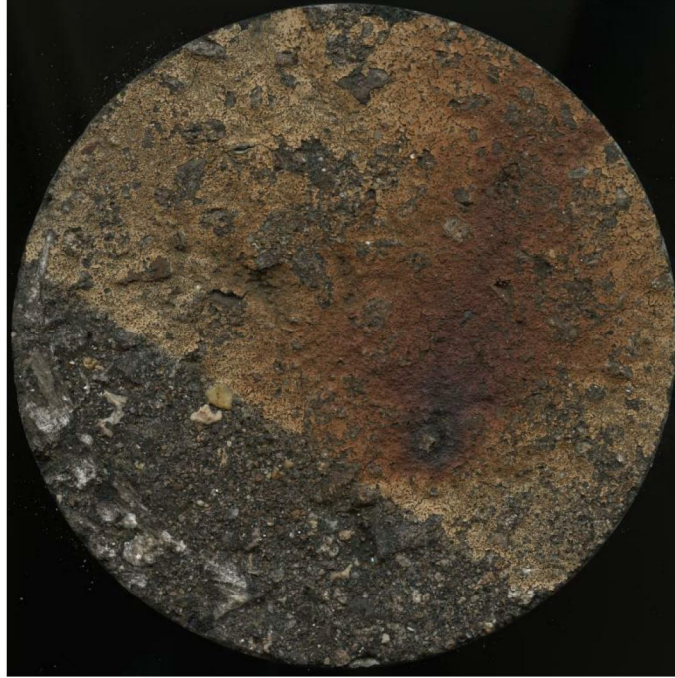
Figure 20 Laconia core showing source of iron staining

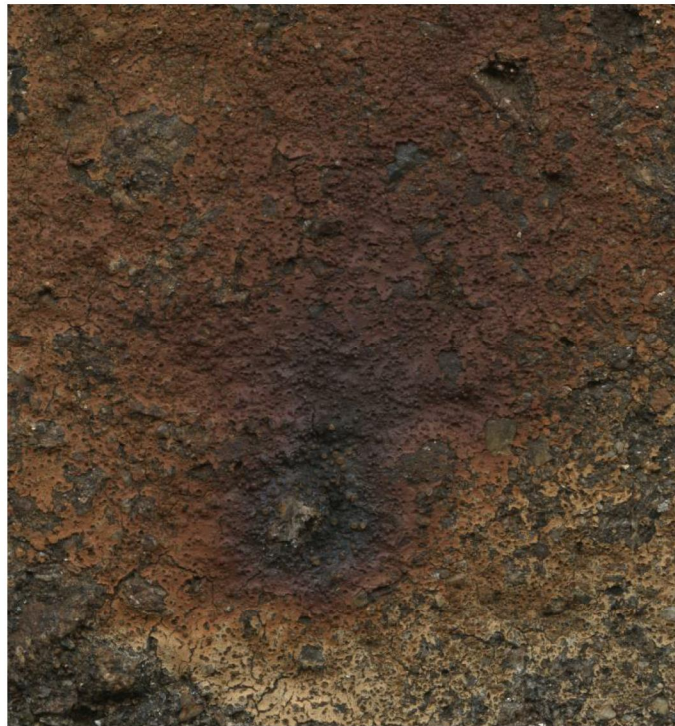
Figure 21 close up of Figure 20 showing major staining

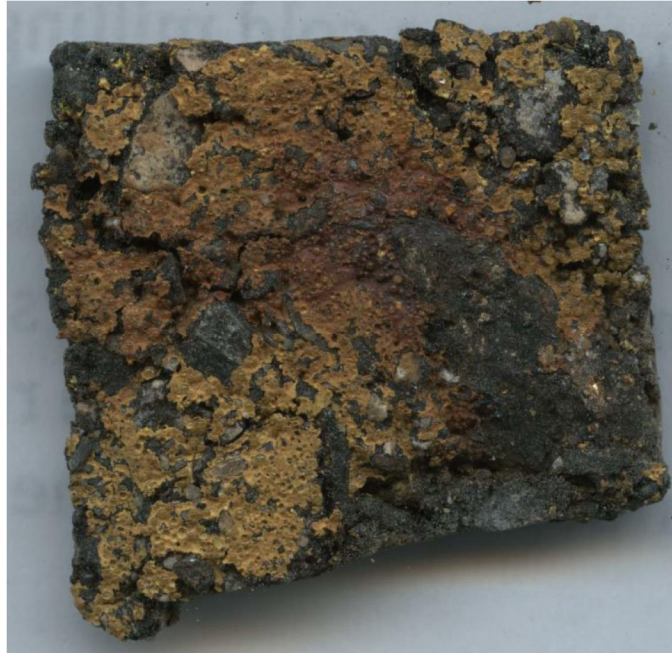
Figure 22 Whitefield paint chip showing source of iron staining

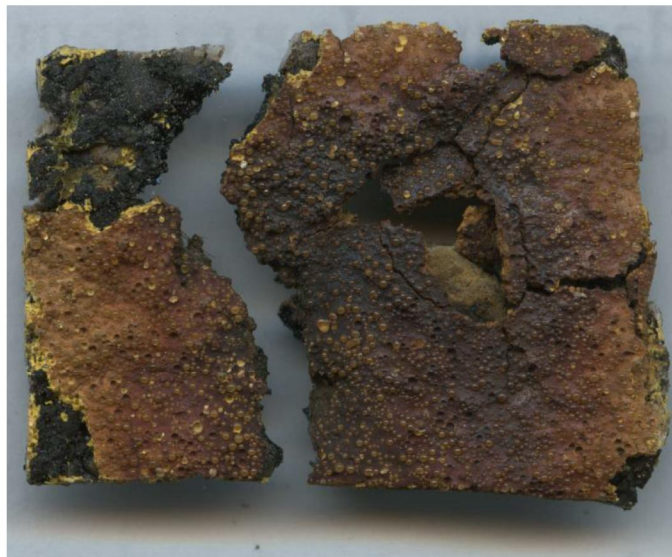
Figure 23 Whitefield paint chip showing large area where staining emerged

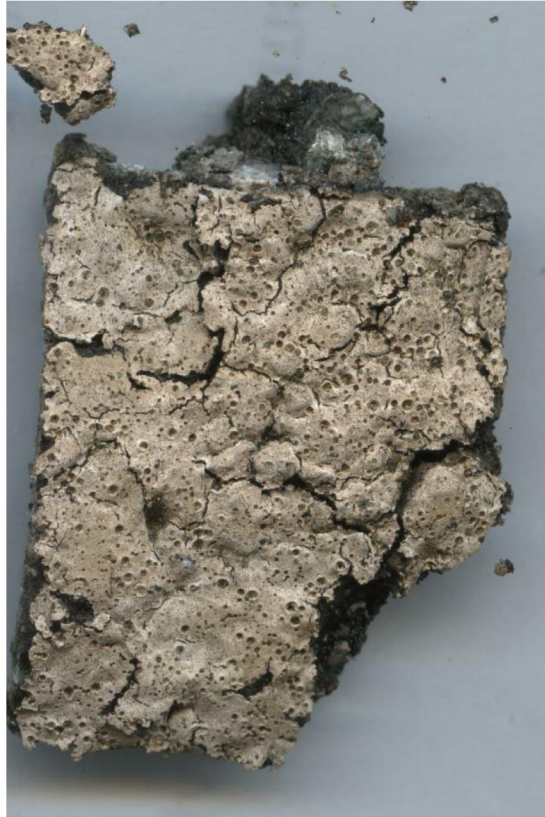
Figure 24 Whitefield paint chip showing little staining

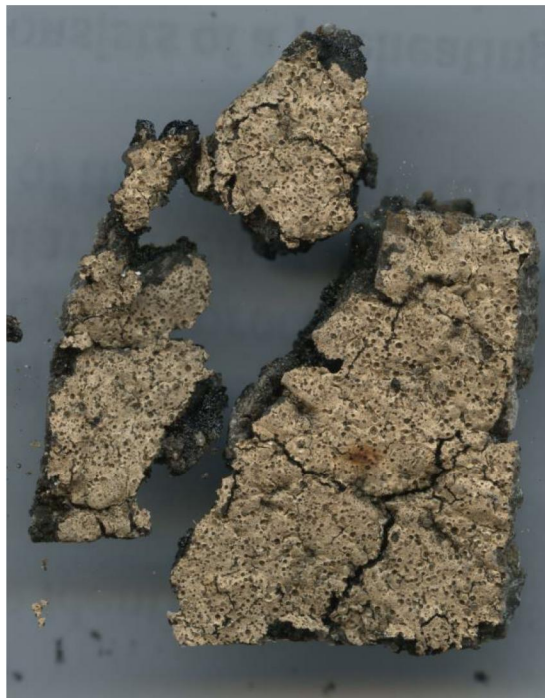
Figure 25 Whitefield paint chip showing small source of staining

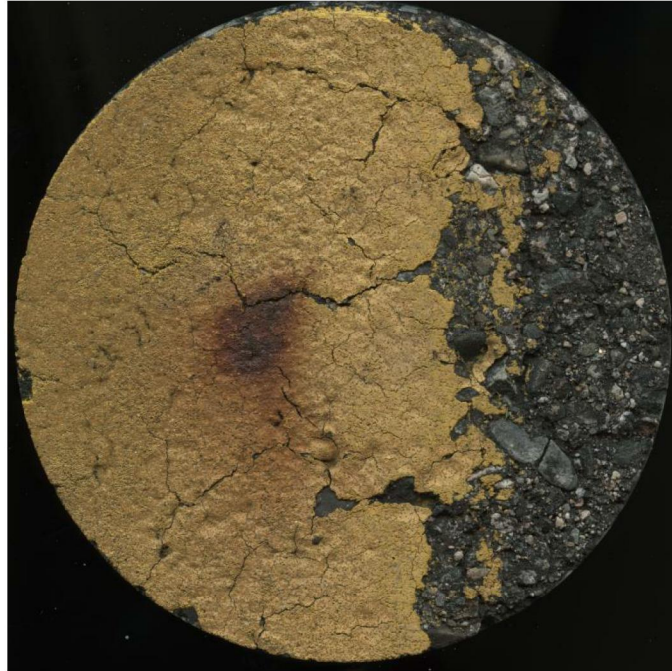
Figure 26 Whitefield core showing source of iron staining

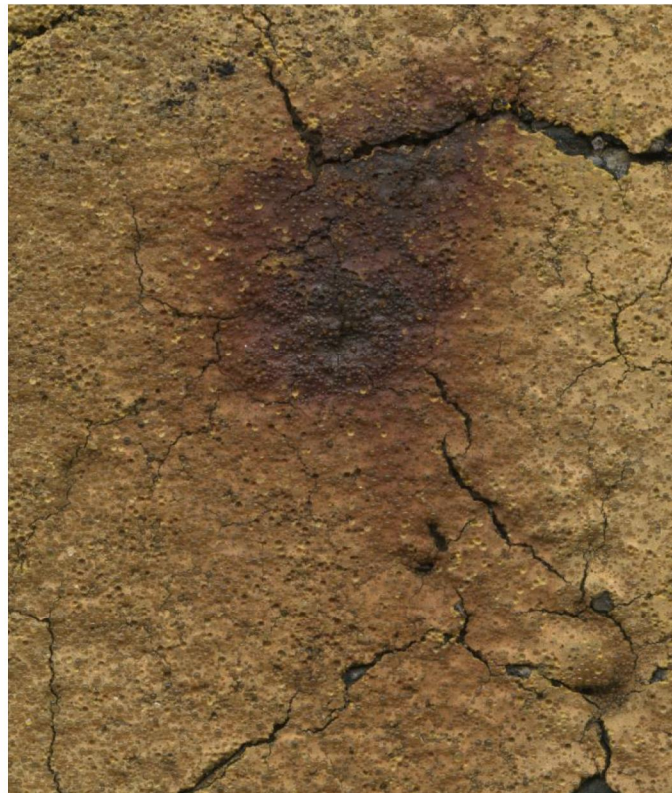
Figure 27 Whitefield close up of Figure 26 note intensity of light color of paint under glass beads lost during coring

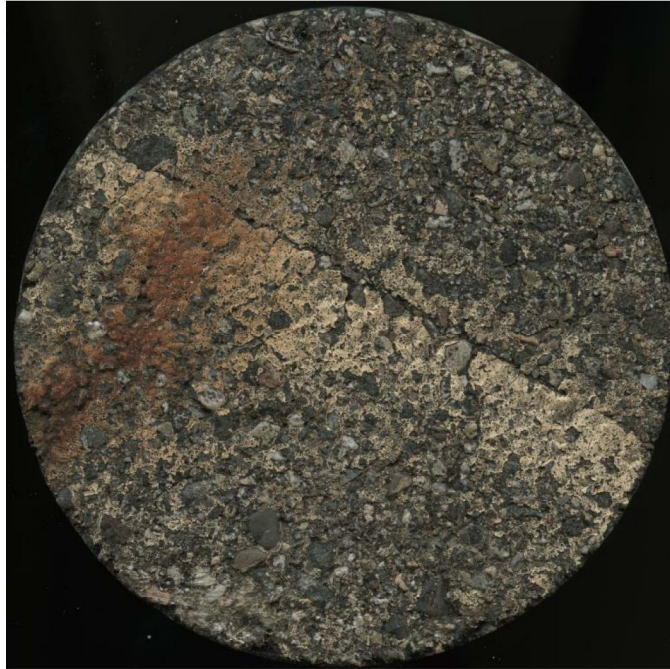
Figure 28 Whitefield core showing staining source

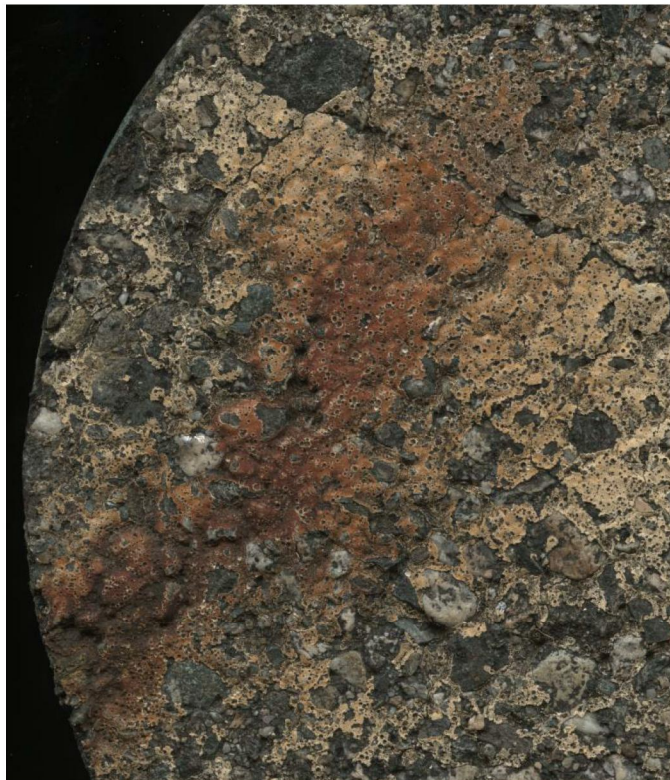
Figure 29 Close up of Figure 28 note degree of heavy staining

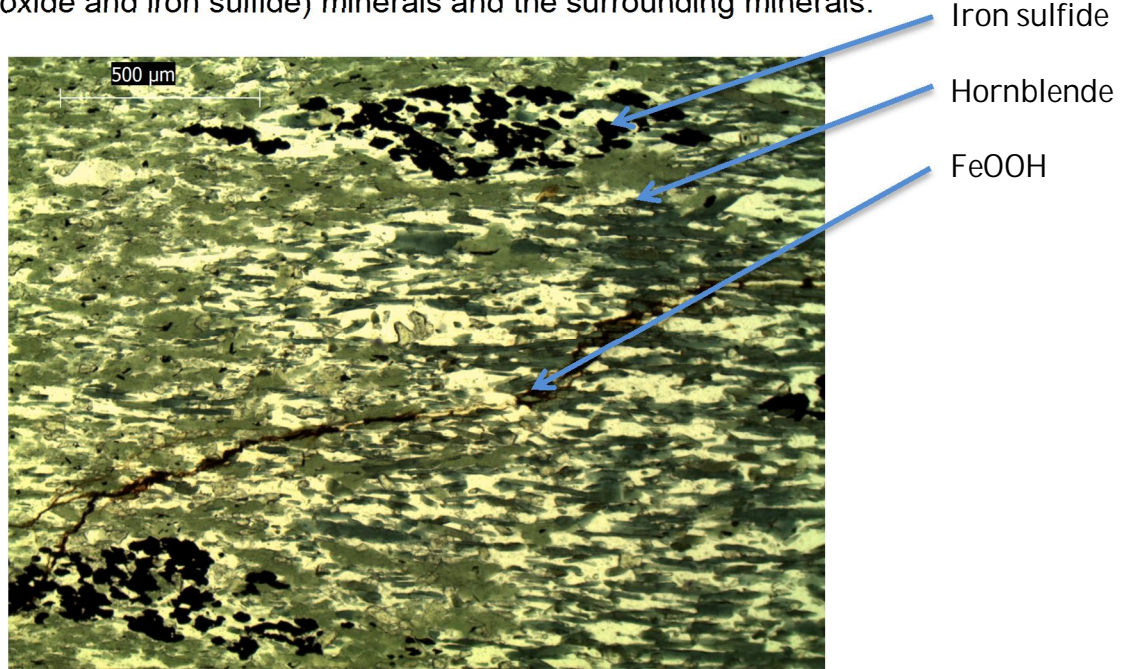
K-1-1 (Sample K-1, fragment 1) Strongly oriented green amphibole, clear quartz and feldspar, poikiloblastic pyrite (black) and cross cutting dark brownish black alteration fracture filling (probably FeOOH). 4X, PPL

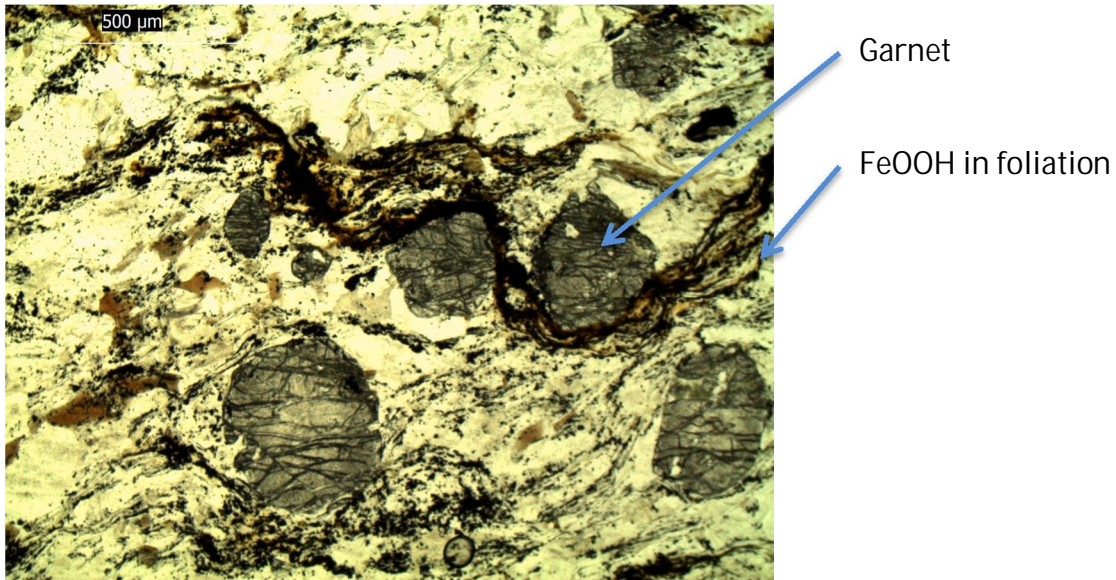
K-6-3 Garnet micaceous quartzite with ~5% opaque (likely magnetite as this fragment is weakly magnetic). Six garnet grains (porphyroblasts) stand out in this image. Biotite foliation is deflected around the garnet grains and is stained by iron oxide hydroxide (FeOOH). 4x, ppl

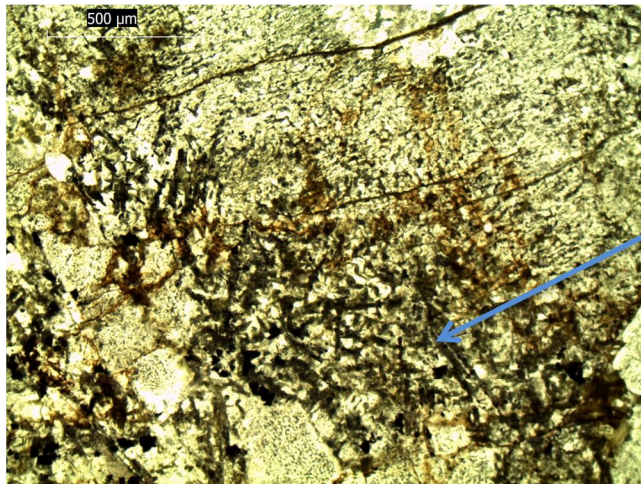
Highly altered zone
with FeOOH staining

H-1-5 Altered metavolcanic porphyry. Coarse plagioclase grains are zoned, mantled, and altered to fine-grained white mica, set in a fine-grained matrix. Ferromagnesian and opaque minerals are altered to iron oxide hydroxide

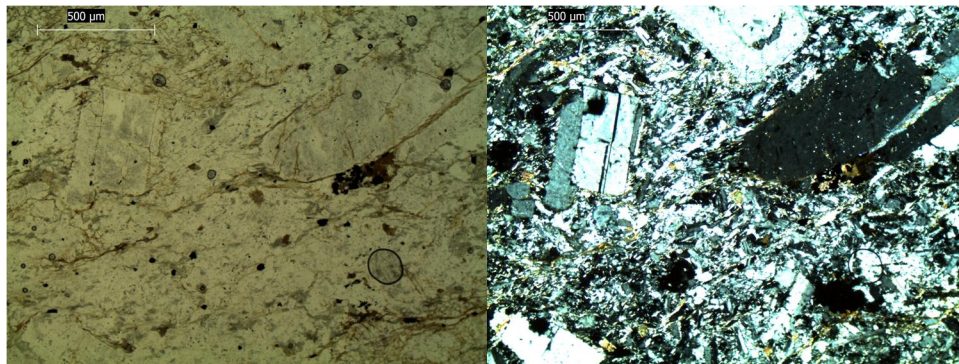
H-1-6 Felsic metavolcanic porphyry shown in ppl and xpl contains randomly oriented twinned plagioclase phenocrysts set in a fine-grained quartz-feldspar matrix. Iron oxide hydroxide alteration is apparent along grain boundaries and a few fractures. 4x
